**BLUE LAKE
COMMUNITY DEVELOPMENT
DISTRICT**

**LEE COUNTY
REGULAR BOARD MEETING
MAY 9, 2023
1:00 P.M.**

Retaining Wall Failure Analysis – Blue Lake

Prepared For: Blue Lake Community Development District
c/o Kathleen Meneely, Manager

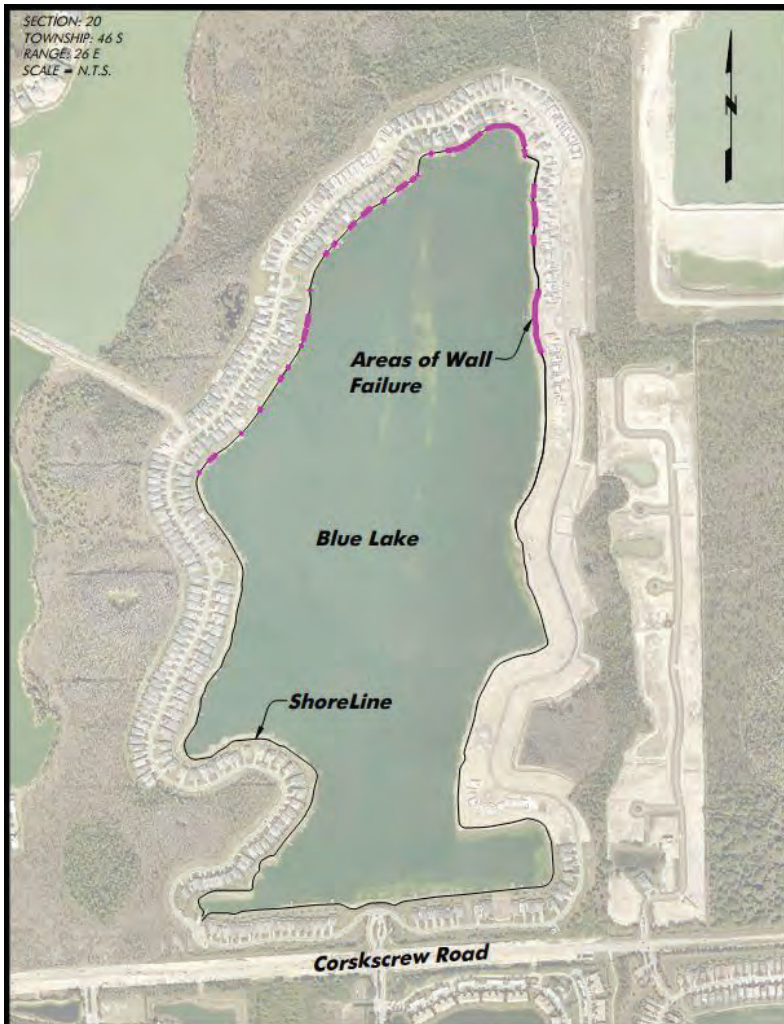
The drawing to the left shows 3,350 linear feet of retaining wall that suffered significant failure, with additional sections suffering more minor failures following Hurricane Ian.

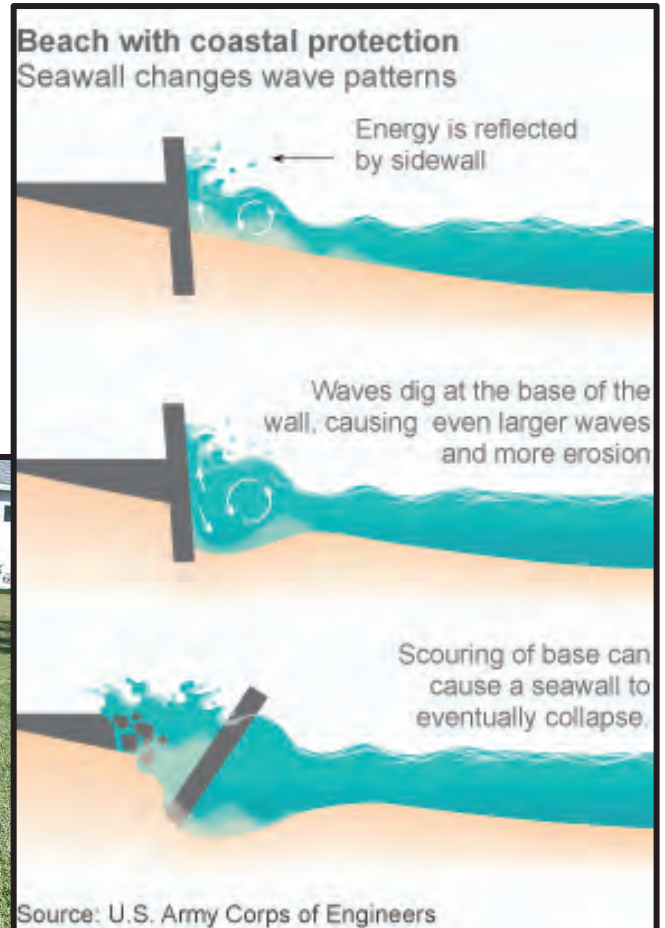
The wind generated waves impacted the northern shore of the lake and caused toe scour on the wall. Whereas a riprap revetment or natural shoreline with a slope gradually dissipates wave energy, a vertical wall provides a smooth surface which reflects the wave energy. As these waves are reflected turbulence is created at the base, which then lowers the shoreline profile, and in turn allows larger waves to impact the wall creating a cycle of erosion. This cycle stops when either the storm stops or the depth waterward of the wall has reached the maximum breaking depth of the waves. Toe scour on a vertical wall will result in erosion greater than if the waves were impacting a sloped lake bank or a riprap revetment. The lack of scour protection, steep drop off waterward of the lake, and vertical wall placement made this wall design especially susceptible to toe scour.

To the right is a diagram illustrating the process of waves causing toe scour on a vertical wall. As waves are reflected by the wall, they create turbulence which removes sediment from the toe of the wall. This effect on a vertical wall can lead to increased erosion when compared to a sloping shoreline left in its natural condition. Below is a photo showing substantial toe scour along the north shore of the lake. The sandbar waterward of the wall is a typical sign of toe scour.

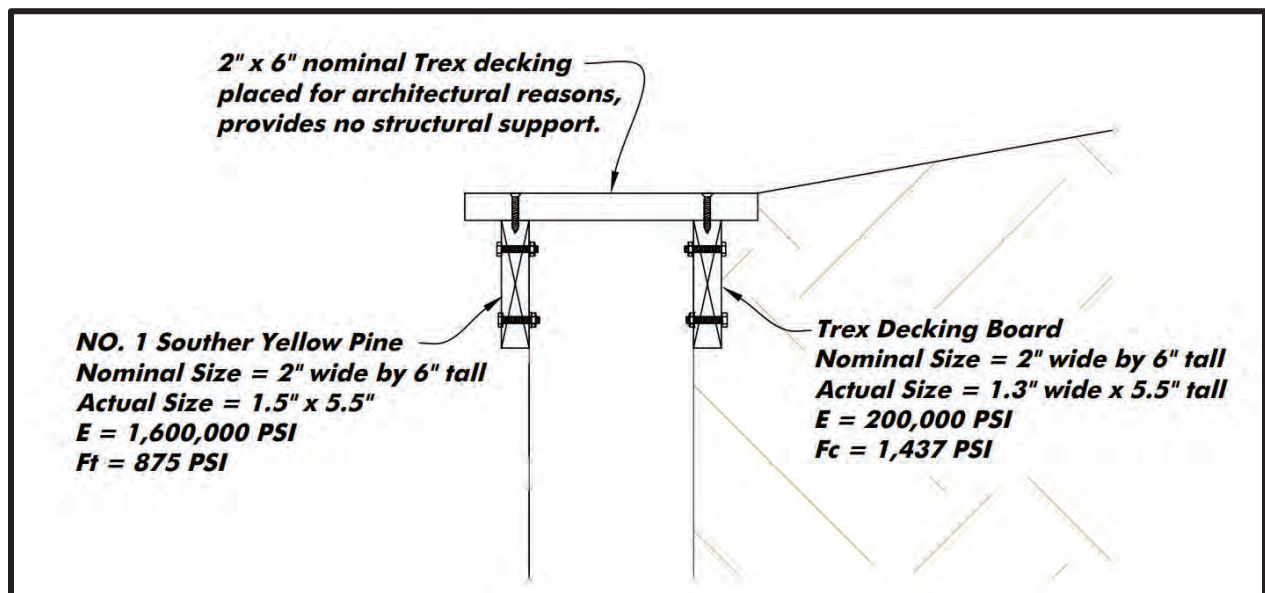
Labeled Retaining wall engineered plans.

Retaining Wall Cap Deflection – A composite cap refers to a cap consisting of two or more materials with different structural qualities. The cap of the retaining wall consisted of a pressure treated No. 1 Southern Yellow Pine wooden 2"x6" on the waterward side and a 2"x6" Trex board on the landward side. While resisting the lateral soil pressure and hydrostatic pressure imposed on the wall the waterward wooden board is put in tension and the landward Trex board is put in compression.

Trex boards are not typically used in structural applications due to the products tendency to deform under load. The Modulus of Elasticity (E) quantifies a materials stiffness. The higher the Modulus of Elasticity the stiffer the material and less likely the material will deform while carrying a load. Trex has a Modulus of Elasticity 12.5% that of wood. Imposing the same load on a Trex board as a wooden board will cause the Trex to deform 7 times that of the wooden board. This boards tendency to deform while underload led to the wall's premature failure.

Based on HWA's field observations the cap suffered deformation at an exposed face of 2.4'. Given the expected scour a replacement wall would fail if 50 MPH winds occurred across the longest fetch distance of the lake. If remedial measures are not taken to prevent future toe scour a replacement cap board would fail prior to the design life of the wall.

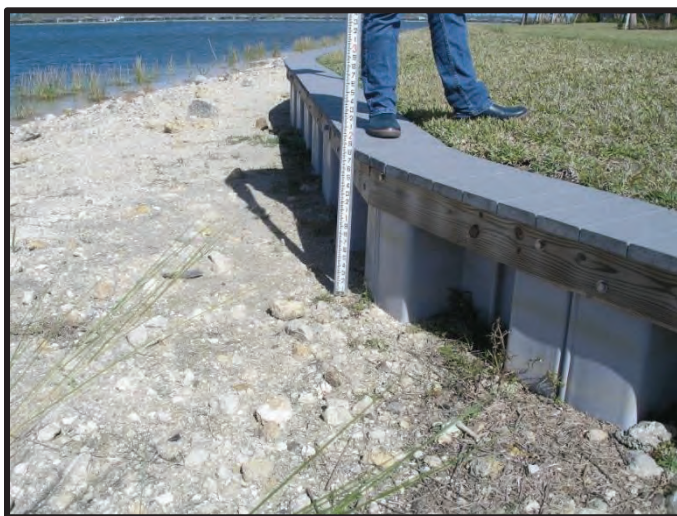
Case 1 (1.75' to 2.4' exposed face): These sections were generally located along the southern shore of the lake and along coves protected from wave action on the lake. We observed no failures or deflections in the sections of the wall which maintained this level of exposed face. The lake bank waterward of the wall was sandy with some small rocks and sparse immature littoral shelf plantings. The lack of toe scour and erosion at these sections is attributed to a lack of wind and wave exposure.

To the left is an example of a Case 1 retaining wall located on the south side of the lake, unaffected by Hurricane Ian waves. The exposed face is 1.8' and little erosion has occurred. Some rocks are present in the lake bank, but their size is too small to prevent erosion and the Littoral Shelf Plantings are not present at the toe of the structure.

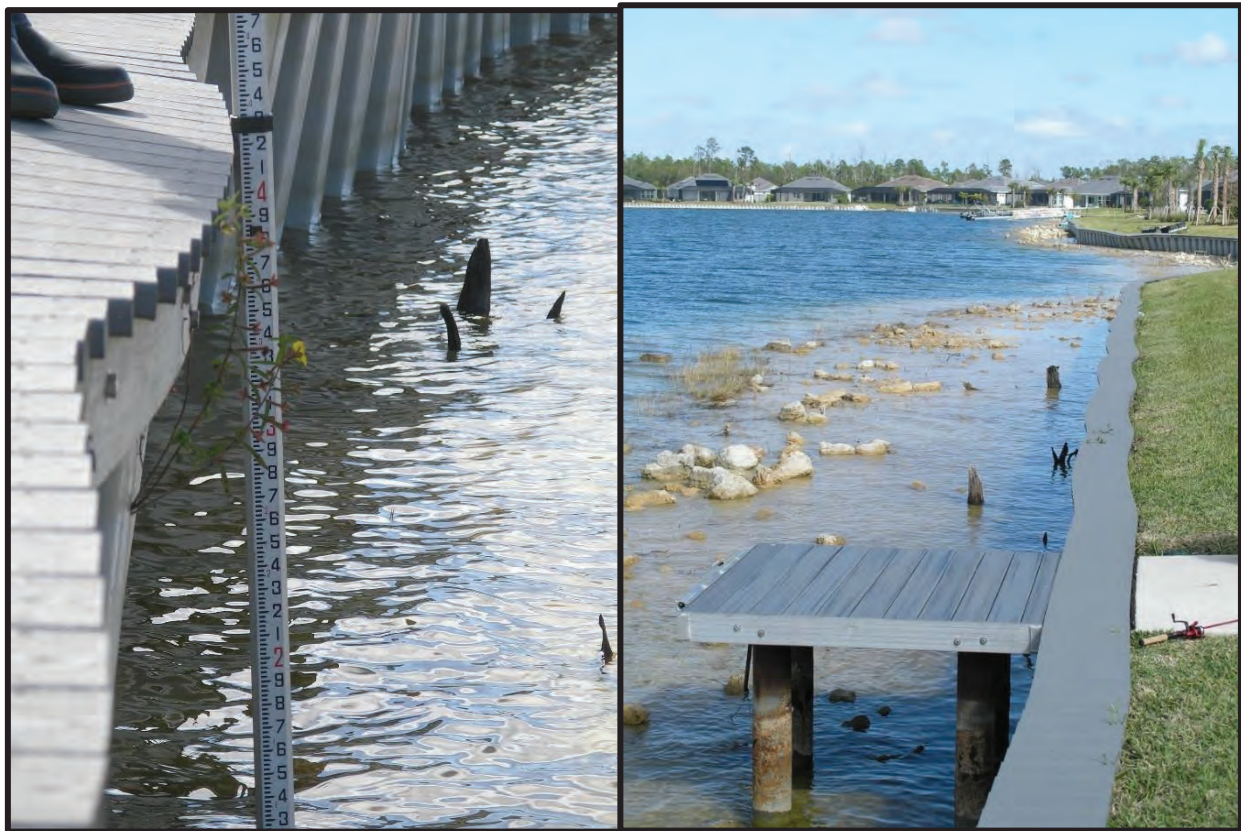
Case 2 (2.4' to 4.2' exposed face): These sections were located along the northern shore of the lake and were exposed to greater wave action. Substantial toe scour occurred as a result of wave action against the wall. At this height of exposed face, the soil pressure behind the wall surpassed the structural capacity of the cap boards. The cap boards did not surpass their ultimate structural capacity but reached a level of stress that caused them to fail through deflection. The cap board deflection created “wavy” walls where the retaining wall bows out waterward between the earth anchor tiebacks which hold the top of the wall upright. The lake bank waterward of the wall was sandy with some small rocks and littoral shelf plantings were likely removed by the erosion.

To the right is an example of the “wavy” wall effect observed as the exposed face increases more than 2.4'. Some small rocks are seen in front of the wall, but their small size and inconsistency cannot be relied on for erosion protection. Below is a photo showing more extreme waterward leaning with an exposed face of 4.2' and is near complete failure.

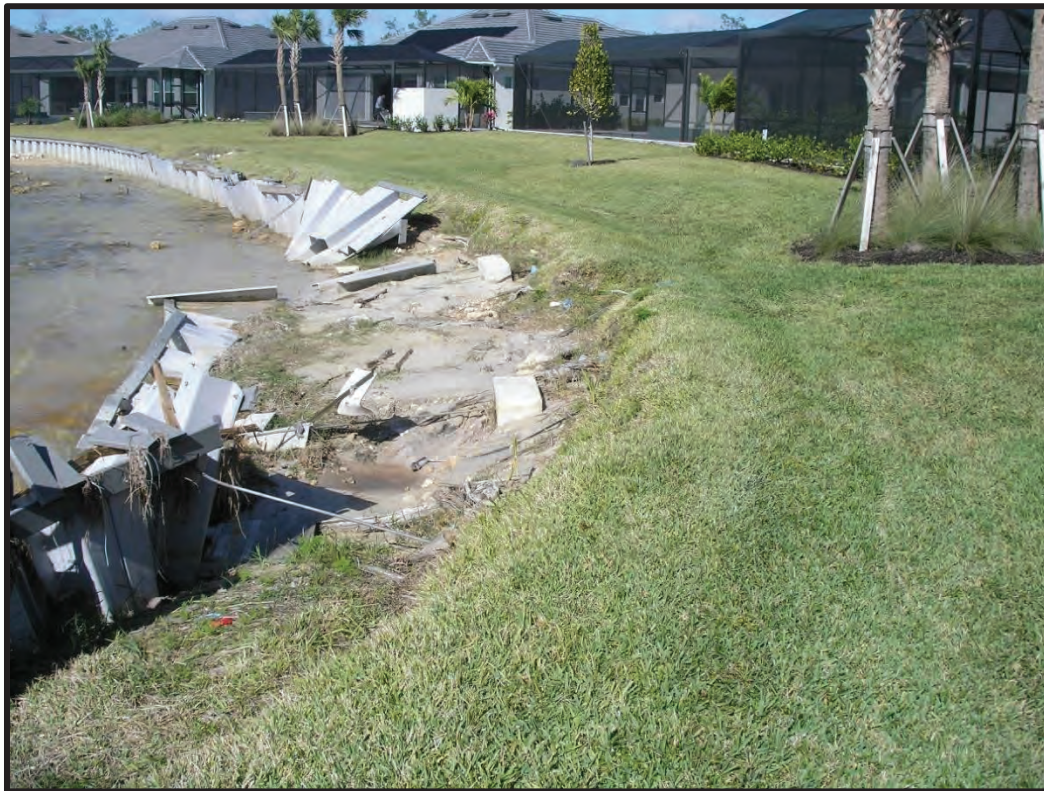
Case 3 (4.2' exposed face or greater): These sections of wall were generally located in areas of the lake where wave action would have been more concentrated, such as concave sections or protruding sections with greater exposure. At this amount of exposed face, the soil pressure behind the wall surpassed the structural capacity of the entire wall. In some instances the cap board snapped, in others the panel toes kicked out, and in others sections the concrete deadman were pulled forward. The only structural member to not fail were the Vanguard Corrugated Vinyl panels which did not break. These sections of shoreline have the same level of erosion protection as the rest of the lake but were exposed to more significant wave action. Any section of retaining wall subject to this level of wave action would have failed.

Above is an example of total retaining wall failure. This section was located on the north shore of the lake where the concaved shape concentrated wave action. The exposed face was estimated to be 4.6' at this section. Some small scattered rocks and plantings are seen in front of the retaining wall.

For sections of the wall which have already failed HWA recommends disassembling the wall and reinstalling panels with a cap sized to resist deflection. Many of the Vanguard panels may be reused. In sections of deflection greater than 2.5" the soil behind the panels would need to be excavated and the panels brought into alignment and a stronger cap board installed. These repairs would be in conjunction with an offshore breakwater to prevent future failures from occurring.
