**BLUE LAKE
COMMUNITY DEVELOPMENT
DISTRICT**

**LEE COUNTY
REGULAR BOARD MEETING
MAY 9, 2023
1:00 P.M.**

Retaining Wall Failure Analysis – Blue Lake

Prepared For: Blue Lake Community Development District
c/o Kathleen Meneely, Manager

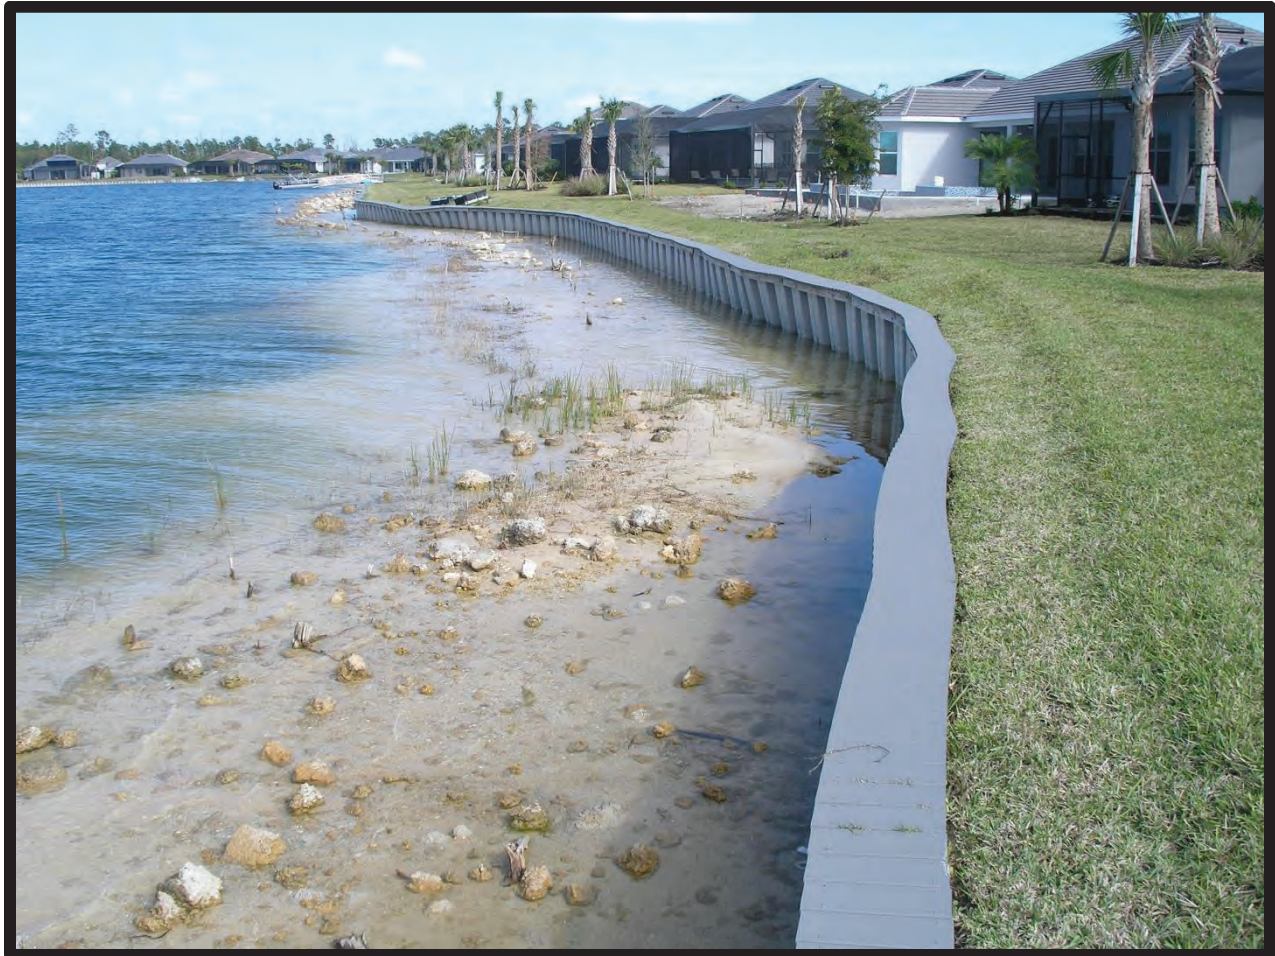
The drawing to the left shows 3,350 linear feet of retaining wall that suffered significant failure, with additional sections suffering more minor failures following Hurricane Ian.

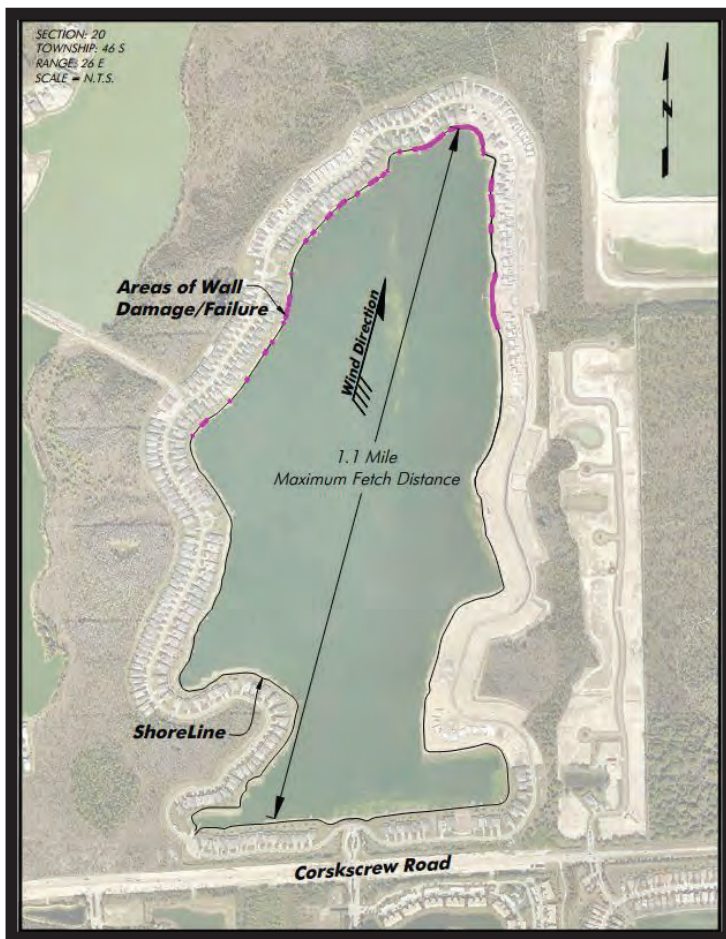
The U.S. Army Corps of Engineers Shore Protection Manual Volume 1 provides tables (Figure 3-27 through 3-36) used to determine the wave height of wind generated waves based on fetch distance, water depth, and sustained wind speeds 30 feet from the water's surface. Based on a fetch distance of 1.1 miles, a typical depth of 20 feet (as reported by the site civil engineer), and a sustained wind speed of approximately 70 miles per hour we can calculate that the retaining wall was subject a significant wave height of 3.1 feet for the duration of the storm.

To the left is a drawing showing the maximum fetch distance and approximate wind direction during the hurricane.

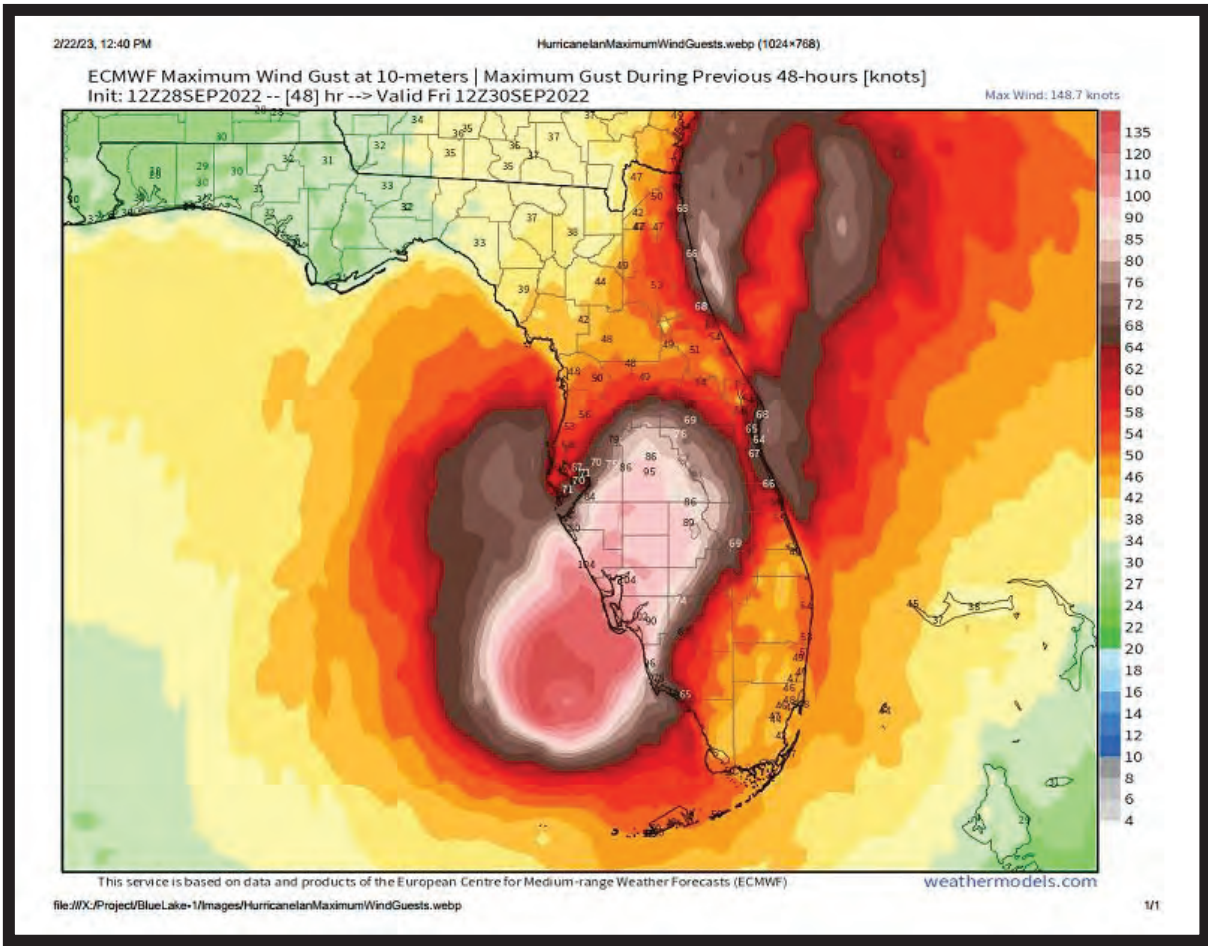
Below is a map by the ECMWF wind prediction model for estimated maximum winds caused by Hurricane Ian showing gusts of 90 miles per hour at the site.

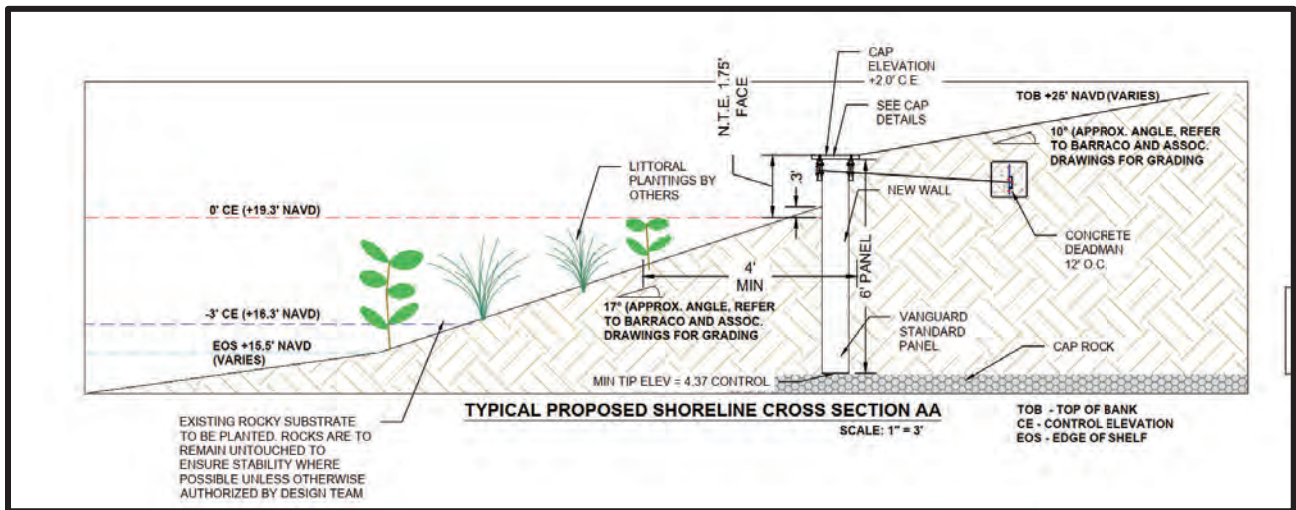
Retaining wall engineered plans

Retaining Wall Plans – To stabilize the lake bank a retaining wall was constructed along the shoreline of Blue Lake. The retaining wall consisted of 6' Vanguard Standard Vinyl sheet panels, a composite cap consisting of wood and Trex, and Concrete deadman on 12' centers. The toe of the Vanguard panels was supported by passive earth pressure and the top of the wall was anchored by concrete deadman on 12' centers with the composite cap distributing the horizontal loads between the earth anchors. The top of the wall featured a Trex walkway for aesthetics which provided no structural support to the wall.

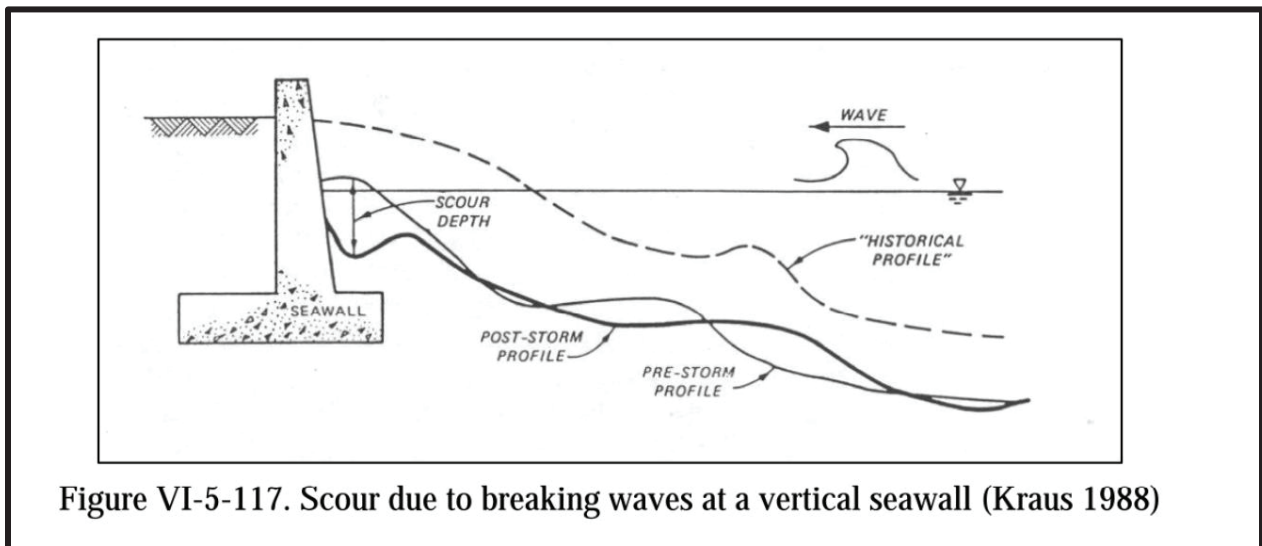
Figure VI-5-117. Scour due to breaking waves at a vertical seawall (Kraus 1988)

Toe Scour – The replacement wall should be designed to withstand the level of toe scour expected following the design storm. The level of toe scour to be expected is a function of the wave height impacting the shore, the level of scour protection provided, and water level during the storm.
