BLUE LAKE COMMUNITY DEVELOPMENT DISTRICT

REGULAR BOARD MEETING JULY 9, 2024 3:00 P.M.

The Blue Lake Community Development District (Blue Lake CDD) engaged Cummins Cederberg, Inc. (Cummins Cederberg) to investigate a retaining wall that experienced damage during Hurricane Ian and to conduct an alternatives analysis to evaluate various options to restore shoreline stabilization along the Blue Lake development's waterfront. A cursory inspection of the existing shoreline was conducted by a Cummins Cederberg coastal engineer on March 5th, 2024. Concurrently, a Cummins Cederberg marine biologist documented the existing environmental conditions at the site. Cummins Cederberg was also tasked by the Blue Lake CDD (Client) to conduct an in-depth assessment of different shoreline stabilization options based on the inspections and subsequent discussions with the Client to provide a baseline document (i.e., alternatives analysis) to support the Client's strategy and decision process on which option to move forward with. This alternatives analysis report provides a summary of the due diligence completed by Cummins Cederberg relative to the environmental permitting and engineering feasibility o

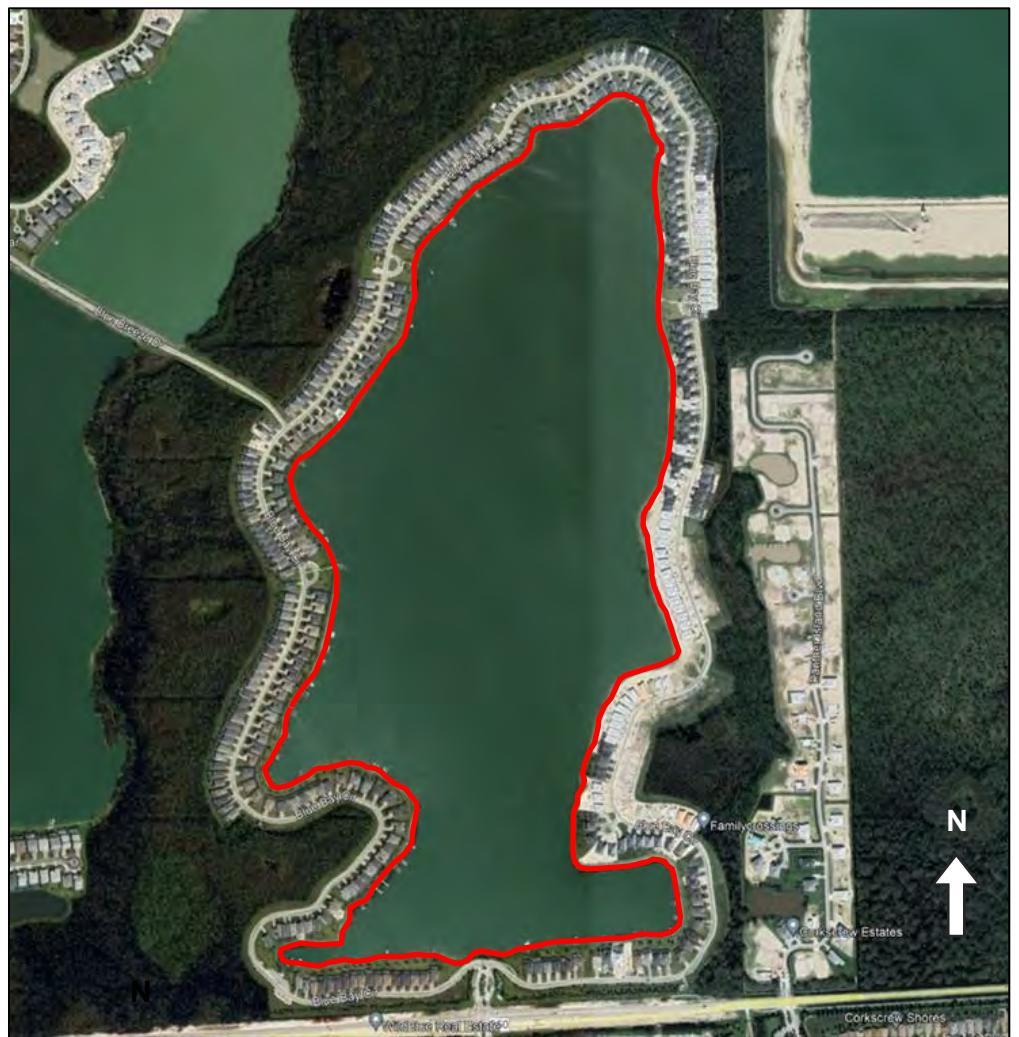
Figure 2. Project site, red line indicating a hardened shoreline structure.

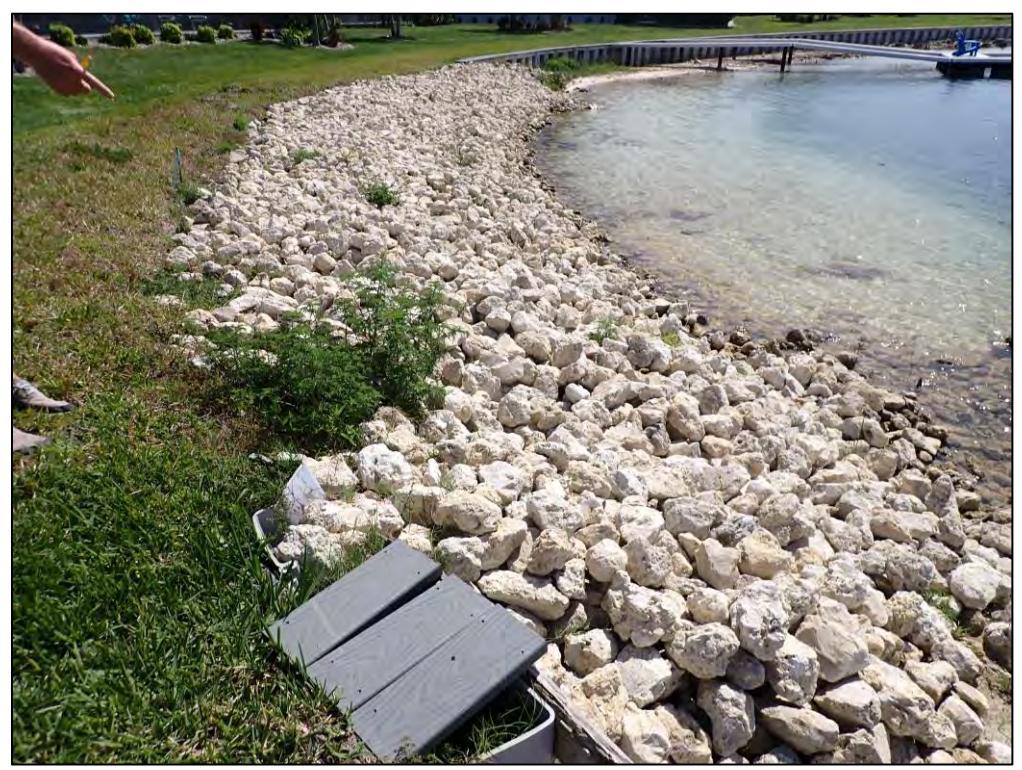
The vast majority of Blue Lake's shoreline is protected by a vinyl sheet pile retaining wall. The lake features a short stretch of shoreline with riprap revetment placed over a failed portion of retaining wall, located on the north side of the lake (**Photo 1**). The lake also features portions of riprap armoring adjacent to a community boat ramp and lake elevation control weirs. Waterward of sections stabilized by a retaining wall, an emergent littoral shelf was observed in varying widths (with an average of 15 feet from the retaining wall face at the time of the site visit) and consisting

Photo 1. Seawall removed/encapsulated with riprap.

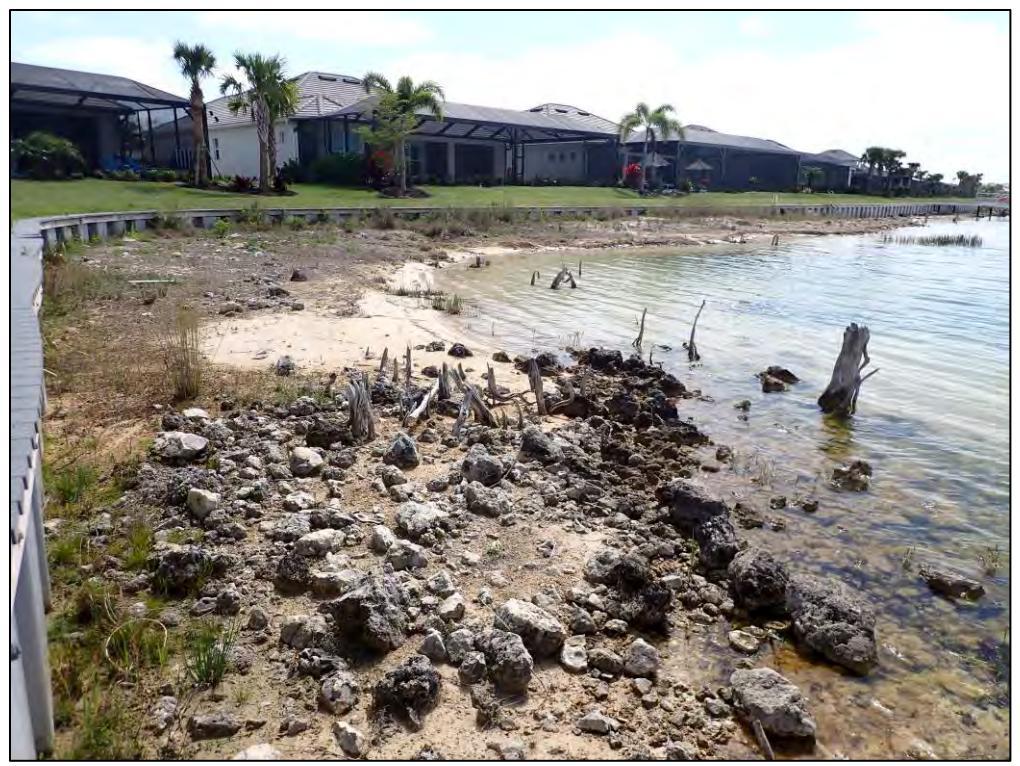
of a rocky substrate with limited vegetation (**Photo 2**). Landward of the retaining wall are residential lots with a raised berm directly behind the retaining wall. The berm height varied between 0.8 to 5.1 feet above the retaining wall cap elevation and were located approximately 6 to 26 feet behind the existing retaining wall. Residential structures and pools were not observed within the immediate vicinity of the retaining wall; however, minor structures including weirs, docks, and outfalls were observed along the shoreline. The retaining wall's exposed height varied between approximately 1 and 4 feet (**Photo 3**). Minor to moderate wave action from boat wake was observed to travel into the littoral shelf and impact the shoreline. Although the wave height was only approximately 1-foot, perpetual action could cause undermining and scour in front of the wall.

Photo 2. Littoral shelf exhibiting limited vegetation.

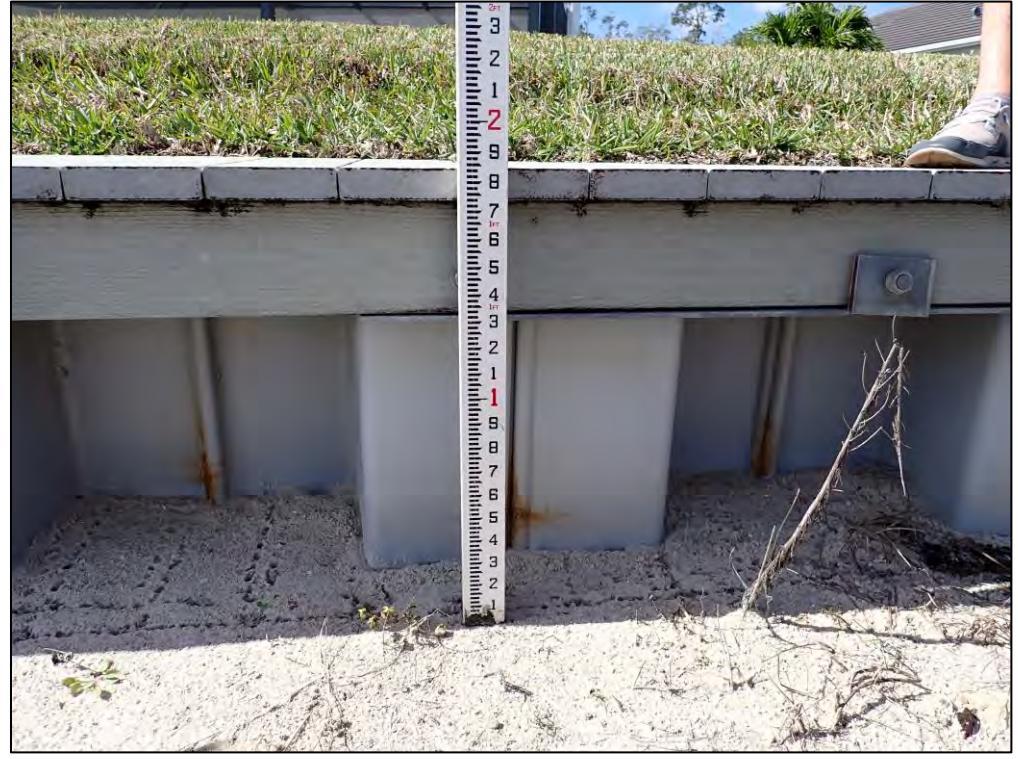
Photo 3. Seawall exposed height of approximately 1.85 feet.

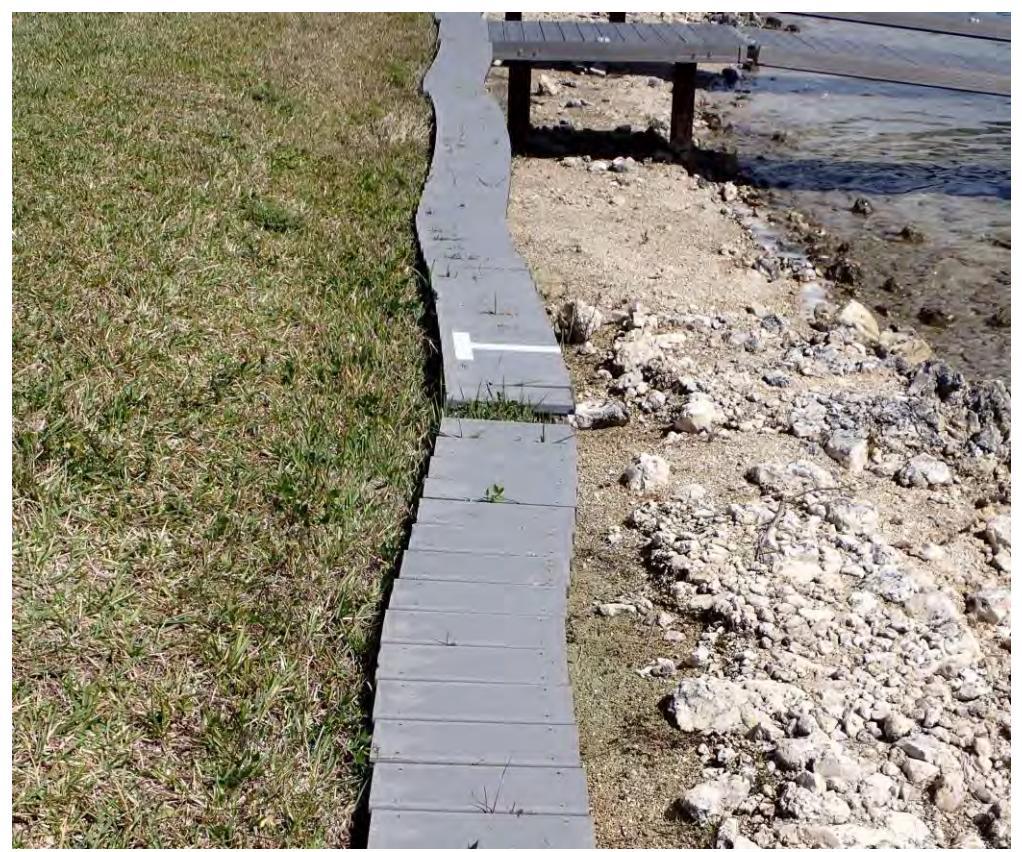
The vinyl sheet-pile retaining wall was typically observed with a composite deck cap installed shore-perpendicular to form a narrow walking area. The sheet piles themselves have a typical length of 6 ft. The sheet piles are connected to tie-backs through a composite and timber beam, spanning approximately 8 ft back into concrete anchors. The condition of these walls varied throughout the Project extent. In the central sections, the vinyl sheet pile walls displayed slight waterward rotation, scour, upland depressions, and scattered cap damage (**Photo 4**). The vinyl sheet pile walls showed signs of more severe damage and wall failure towards the northern end of the lake (**Photo 5**). Sections of the wall displayed severe waterward rotation, to the point of total wall failure. In some of these sections, the wall's anchoring system was left exposed.

Photo 4. Typical central retaining wall.

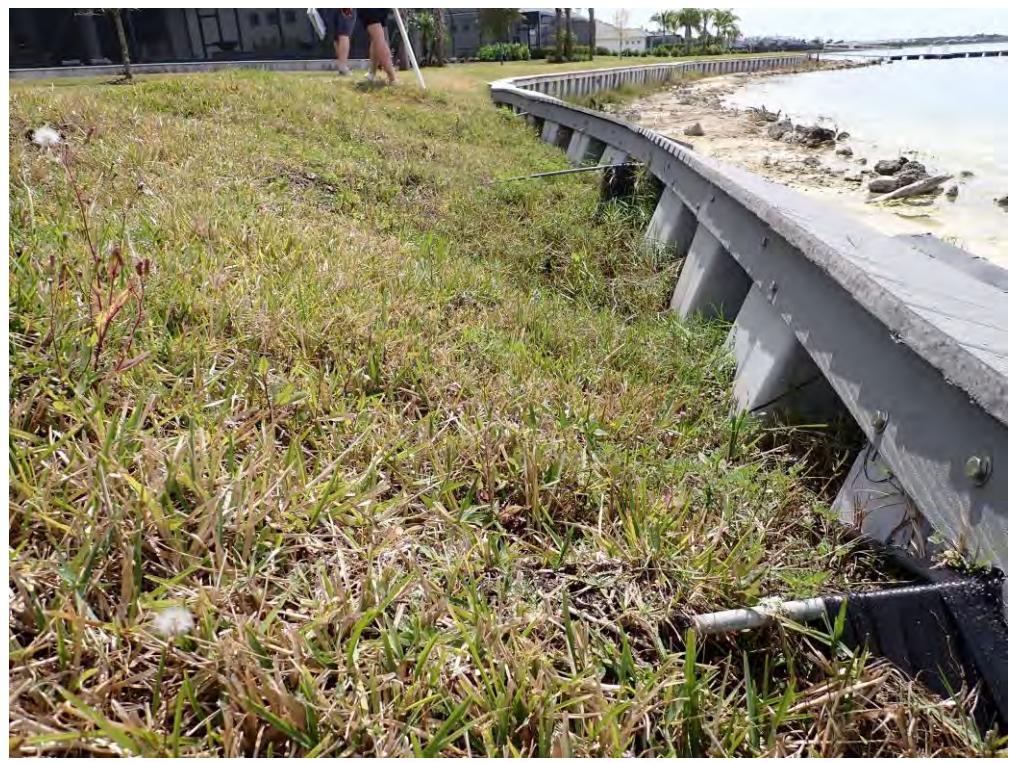
Photo 5. Severe waterward rotation and wall failure.

- A vinyl sheet pile retaining wall with a concrete cap and a rip-rap toe is recommended to stabilize the shoreline in residential areas, where the wave exposure is high and the littoral shelf is narrow. This alternative provides protection against large waves, while minimizing the effects of erosion and scour. Retaining walls have a minimal project footprint and can be installed in the previously permitted footprint with no additional environmental permitting.

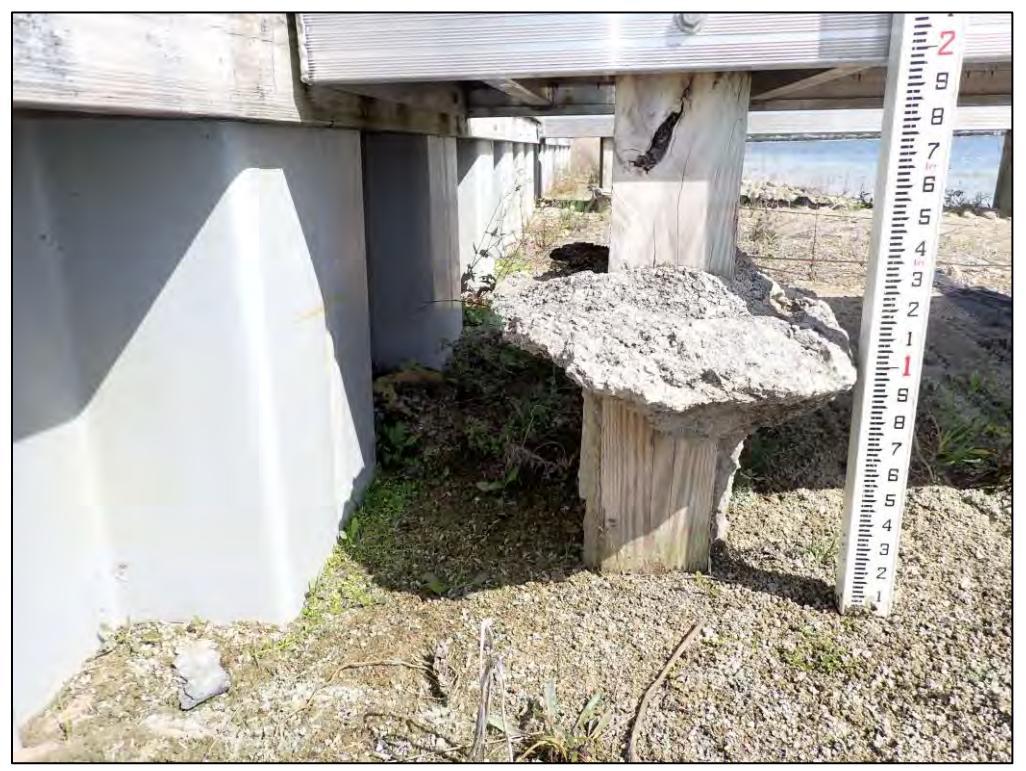
Shoreline vegetation has been documented to provide erosion protection within waterfront systems by lessening wind and wave energy and holding sediment in place. However, it appeared the scarce vegetation provided little protection from erosion. Estimated erosion was observed at approximately one foot of lost sediment on one of the dock pilings as it appeared to have been installed with a concrete footer (**Photo 6**).

Photo 6. Sediment erosion on a dock piling.

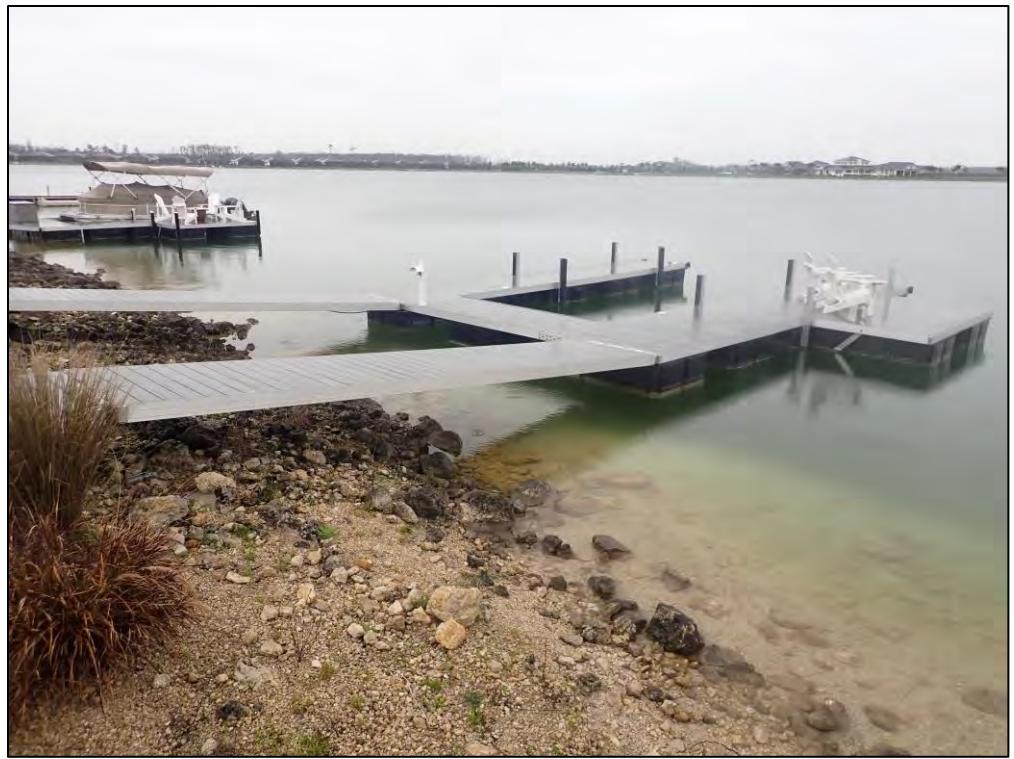
It is important to note that shoreline stabilization methods may impact structures (e.g., personal docks and floating platforms) constructed by adjacent upland homeowners (Photo 7) or associations. During the implementation of shoreline stabilization solutions, portions of the existing docks may be required to be temporarily removed or relocated to facilitate construction. A Memorandum of Understanding (MOU), or similar, is recommended prior to any measures being implemented and to ensure all parties potentially involved or impacted are being considered. For the purposes of this analysis, it is assumed that the upland property owners will have no objection to the shoreline improvements.

Photo 7. Single-family residential dock.

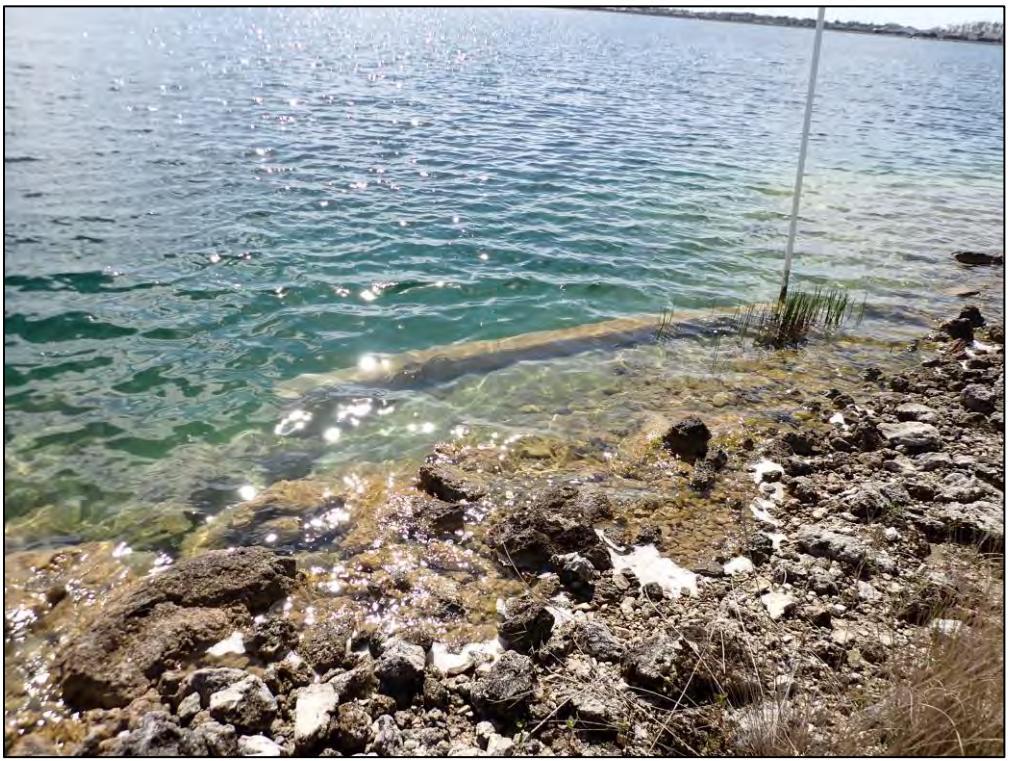
Photo 9. Submerged stormwater outfall headwall.

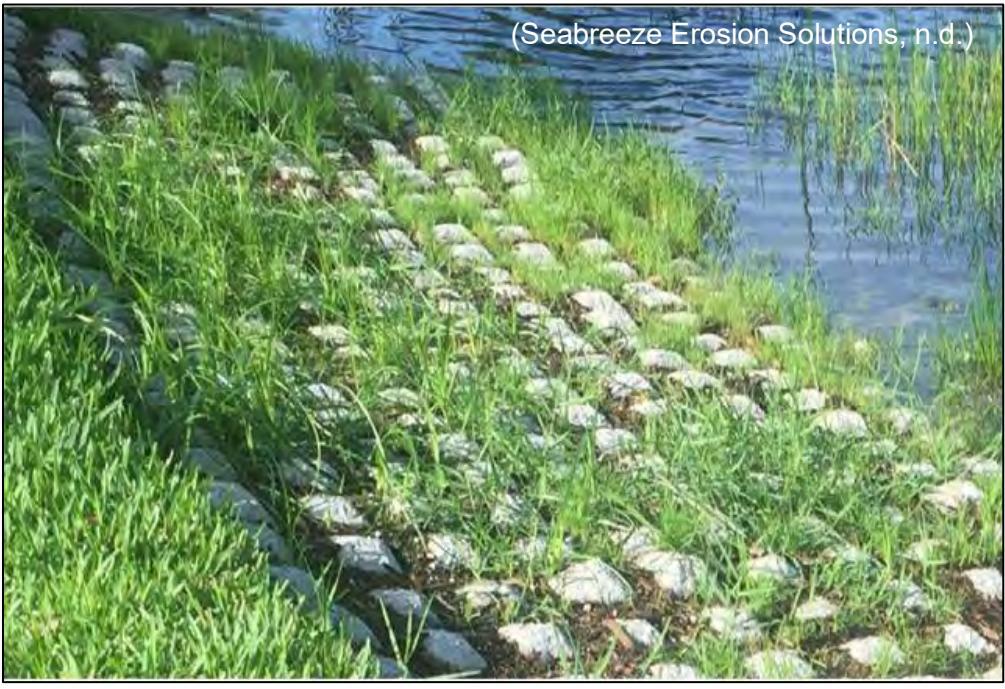
An erosion control mat (Option 3) is a flexible shoreline stabilization product made to adapt to the existing landscape and rest on grade. These mats are typically used along shorelines or in runoff control areas to minimize erosion and retain a specific topographic shape or as boat/kayak ramps. A common form of erosion control mat consists of a series of precast concrete blocks connected

by steel cables to form a mat. The blocks can be open or closed-faced, and different products can have complete coverage of the soil in between the blocks, or the blocks can be spaced to allow vegetation to grow through the mat to limit exposed concrete and have a more natural green appearance (**Photo 10**). It is important to note the erosion control mats will likely require the excavation of existing vegetation, re-grading of the existing embankment, and addition of fill material to prepare the slope.

Photo 10. Vegetation growing through a concrete erosion control mat.

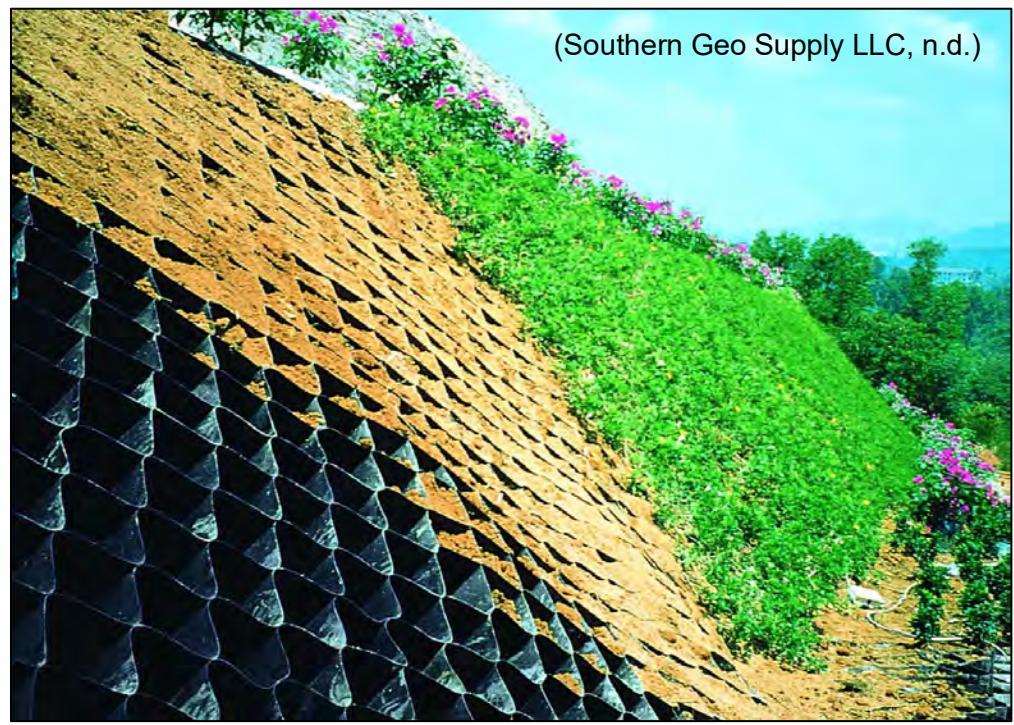
It is important to note that while this option would provide more protection than Option 1 and Option 2, the level of protection would still be less than a more hardened shoreline approach as the Geocells still allow direct interaction between the waves and soil; however, this option should be considered for use in areas that are sheltered.

Photo 11. Geocells with vegetation.

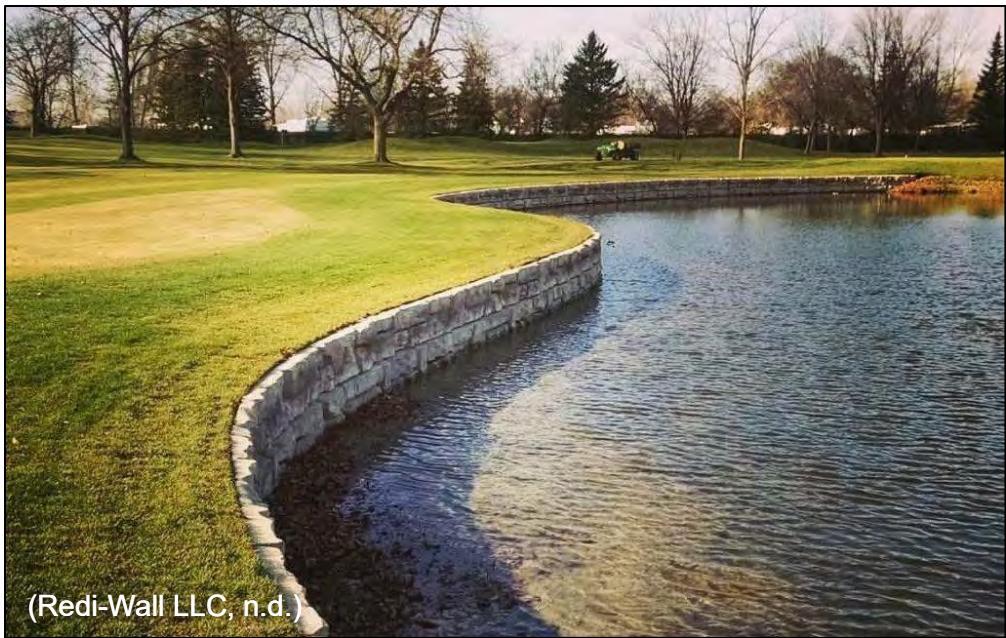
Modular block walls (Option 4) are typically precast concrete slabs that can be stacked to form a nearly vertical retaining wall (**Photo 13**). The blocks can be simply stacked upon each other and connected into grooves designed in the precast mold, or the blocks can be reinforced through various anchoring measures extending into the soil that the wall retains. Reinforcement is typically only required for walls of elevations multiple stories high or containing heavy loading such as emergency vehicles adjacent to the blocks. The molds often have stamping templates to create a rock appearance, as well as multiple color options to look like limestone, granite, or other types of material. The blocks can also be cast to allow for planting space within a concrete pocket to facilitate vegetation growth and a more natural green aesthetic.

It is important to note that these walls appear to lack adequate scour protection when installed traditionally and are prone to undermining or potential rotation. In order to prevent damage from wave action, these walls would have to be partially buried or armored with a rip-rap toe along the mudline, both of which would increase the overall project cost. Further, the individual units are generally required to be brought in by flatbed or boom truck (Redi-Rock International, LLC, 2020) and would require multiple deliveries to provide enough blocks for the required wall section along the shoreline. Further discussion with local contractors to determine the feasibility of a large-scale installation by barge should be completed prior to selecting this option.

Photo 13. Modular block retaining wall.

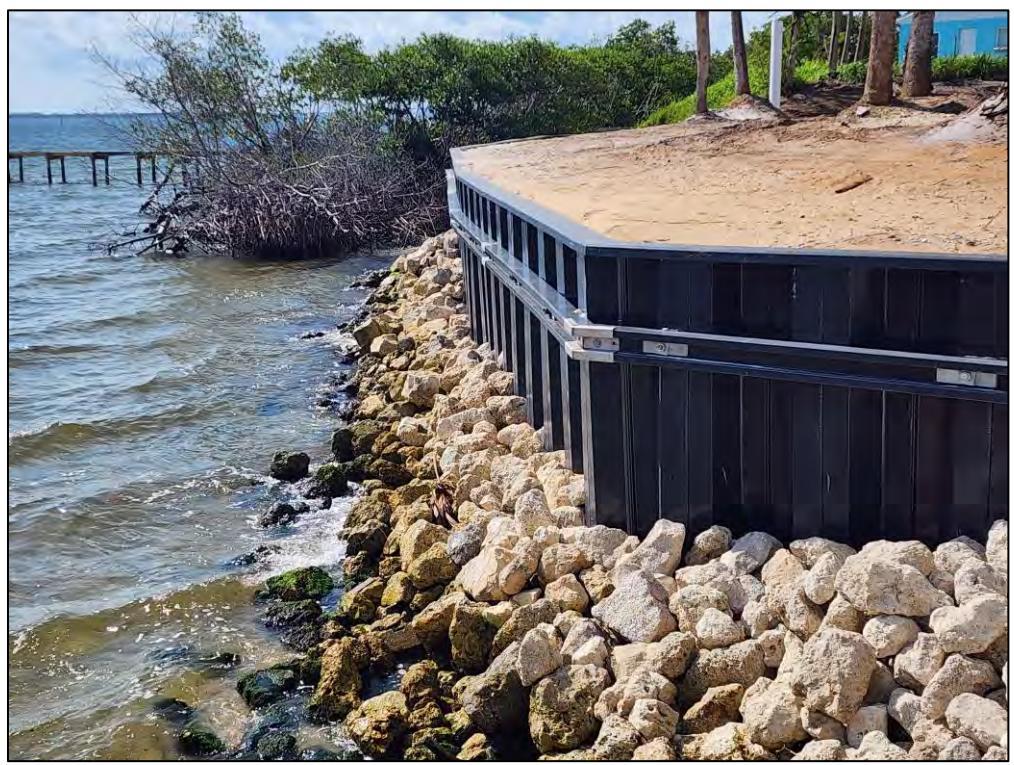
A retaining wall with toe stone (Option 5) is typically a sheet pile wall constructed to retain upland soil and create a vertical face along the shoreline (**Photo 14**). The sheet piles help mitigate incoming wave action and cause waves to reflect back into open water. Many different sheet pile materials could be used to reinforce the shoreline including wood, fiber-reinforced polymer (FRP), vinyl, aluminum, concrete, and steel, and each has its own benefits and drawbacks with regards to price, strength, installation methods, durability, and aesthetic. Depending on the amount of loading on the wall, additional reinforcement measures such as tie backs or batter piles may be required to limit cracking, deflection, and overturning of the wall.

Photo 14. FRP retaining wall with toe riprap for scour protection.

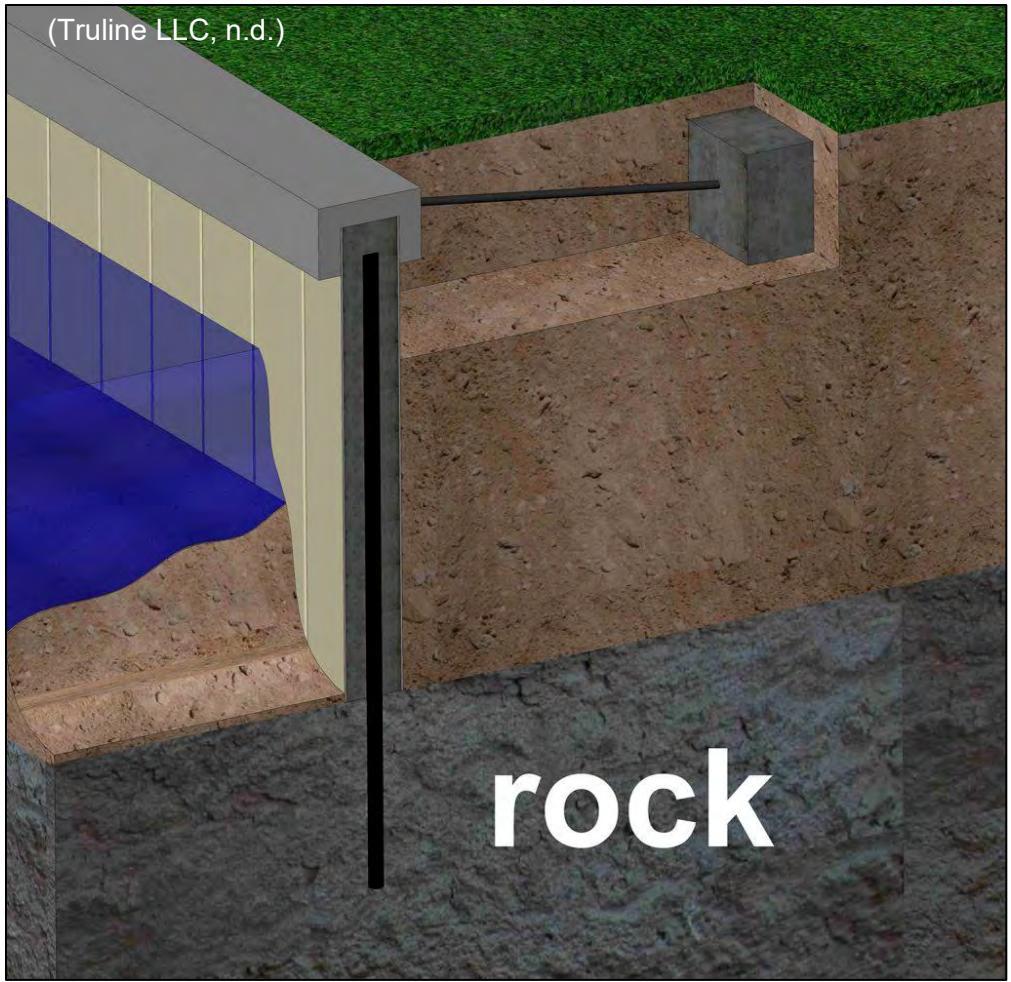
It is our understanding that the Project site has a thick limestone layer located near the surface of the shoreline. The presence of this layer could make the installation of the FRP and vinyl retaining walls more difficult without pre-punching or trenching and should be further evaluated based on a pre-design geotechnical investigation. An option that could also be considered is the use of pin

piles to "toe" the sheet pile into the underlying rock to prevent toe kickout. Truline[®] manufactures a vinyl retaining wall that incorporates the pin pile into the wall as shown in **Figure 3**.

Figure 3. Pin Pile Retaining Wall.

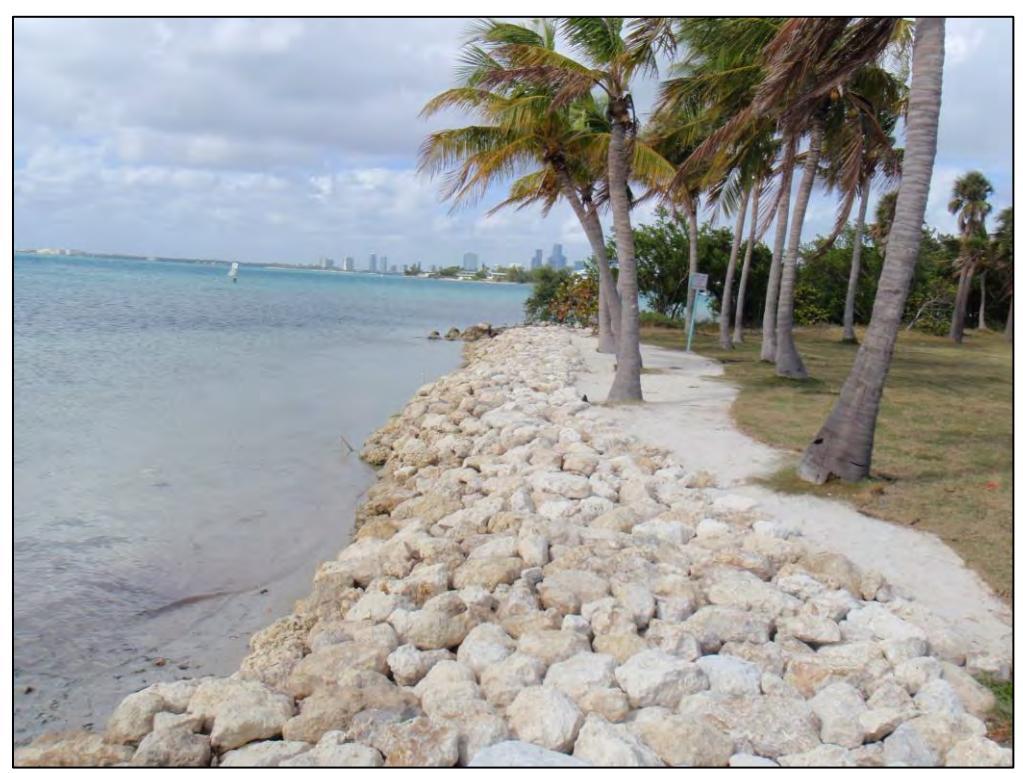
A revetment (Option 6) is a sloped shoreline stabilization method typically consisting of larger armor stone and smaller bedding or core stone resting on geotextile (**Photo 15**). Like the erosion control mats, revetments are sloped and used to dissipate incoming wave action and reduce erosion. The size and quantity of rock depends on the slope and available land perpendicular to the shoreline between the water level and upland infrastructure. Revetments are generally sloped on regraded soil ranging on a vertical to horizontal ratio of 1V:1.5H to 1V:3H.

This alternative would be particularly effective in exposed, open areas of shoreline capable of receiving higher wave energy. A revetment is a more horizontal structure and would require a large footprint than a retaining wall. Due to the presence of limestone mines in the area, shipping costs are expected to be lower; however, the length of shoreline would require large quantities of rock for construction. The service life of a revetment is generally longer than manufactured materials as the only damage typically seen by revetments on inland lakes is settlement or displacement of rocks during extreme events, which can easily be put back in place.

Photo 15. Limestone revetment.

- 2. A rock revetment is recommended to stabilize the shoreline in areas where the upland development is non-residential due to the wider footprint required. Rock revetment is feasible in areas where the wave exposure is high and the littoral shelf is relatively wide. This option provides a high degree of protection against scour and waves. Rock revetments are ideal for use in community held areas to provide a natural look at a lower cost.

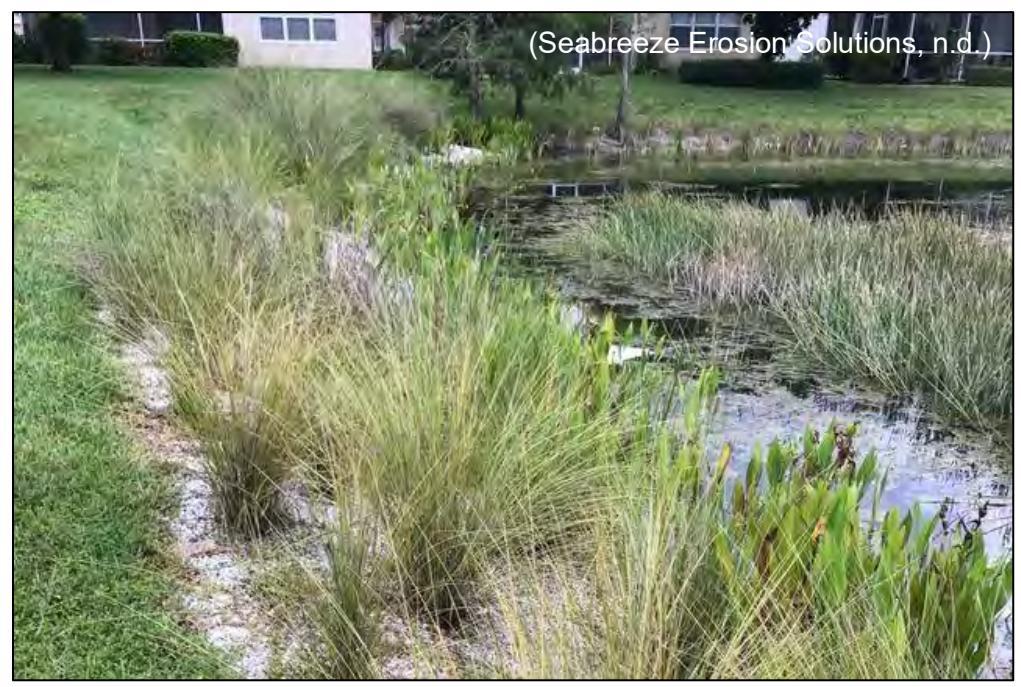
Living shorelines (Option 7) are a green infrastructure technique using native vegetation alone or in combination with hard armoring to stabilize the shoreline (**Photo 16**). The original design of the Project site's shoreline was proposed as a living shoreline with native plantings. Living shorelines require proper design, construction, and maintenance and typically work best in areas with relatively low wave energy. The soil conditions, plant species, and bed elevations are critical for a successful living shoreline. Typical elements in Florida suitable for this site include upland thrush with rock revetments or sills. Successful strategies are reflective of the general site characteristics such as proximity to development, shoreline condition, bathymetry, and wave energy. Plantings, rocks, and other natural materials are successfully used along shorelines in low to moderate wave energy environments with gradual slopes, such as salt marshes, beaches, bays, and other areas. Moderate wave energy environments typically require some level of armoring to sufficiently absorb wave energy and prevent erosion while allowing for habitat conducive to vegetation growth. It should be noted that living shorelines cannot generally be designed for extreme (i.e., hurricane) conditions and some level of damage after these events should be expected.

This alternative could be utilized throughout the Project site, where littoral shelves are approximately 18 feet wide. The living shoreline proposed for the Project features the use of large armor stones installed as an offshore breakwater to prevent erosion and withstand wave energy, even during storm events. Where put in place, this alternative will likely have lower overall costs,

Photo 16. Living shoreline without rock breakwater.

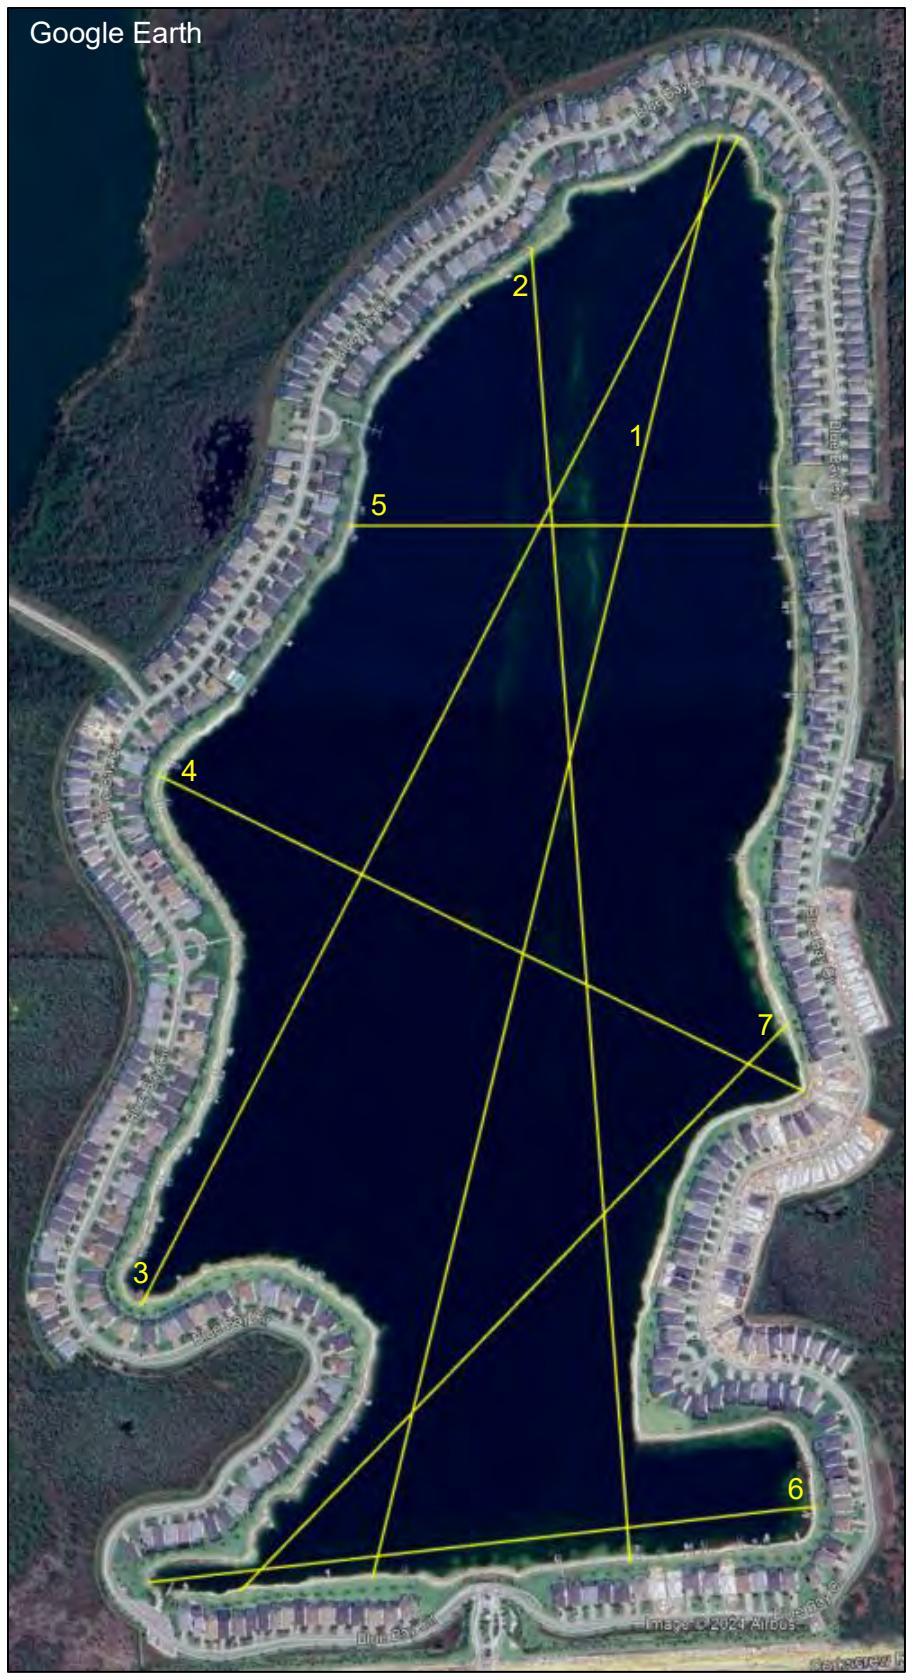
Blue Lake features relatively large open distances between coastlines for an inland lake. The overwater distance along which wind generates waves is called the fetch. Areas exposed to large fetches are particularly vulnerable, as winds generate larger waves over longer distances given enough time during a storm event. A fetch analysis was performed for Blue Lake, which can be found illustrated below in **Figure 4**. Lines drawn depict the areas with the largest fetch exposure. Where fetch is rather long, it is recommended to utilize a more robust shoreline alternative to withstand wave impacts. It is important to note that Line 6 depicts a narrow fetch, which generally is not conducive to wave generation compared to more open areas. As a result, wave generation in the southern section of the lake from east/west winds is expected to be less than the wider areas of the northern part of the lake. A Proposed Site Plan (**Appendix A: Sheet F-2**), illustrates the recommended locations and types of shoreline treatments for each section.

Figure 4. Fetch analysis.

Fetch ID	Distance (ft)	25-Year Storm (4% Chance Per Year)		50-Year Storm (2% Chance Per Year)		100-Year Storm (1% Chance Per Year)	
		<u>Wave Height (ft)</u>	<u>Wave Period (s)</u>	<u>Wave Height (ft)</u>	<u>Wave Period (s)</u>	<u>Wave Height (ft)</u>	Wave Period (s)
1	5,895	1.56	2.26	1.56	2.40	1.56	2.55
2	5,224	1.56	2.17	1.56	2.31	1.56	2.45
3	5,220	1.56	2.17	1.56	2.31	1.56	2.45
4	2,870	1.56	1.78	1.56	1.89	1.56	2.01
5	1,724	1.44	1.50	1.56	1.59	1.56	1.69
6	2,673	1.56	1.73	1.56	1.84	1.56	1.96
7	3,124	1.56	1.83	1.56	1.94	1.56	2.07

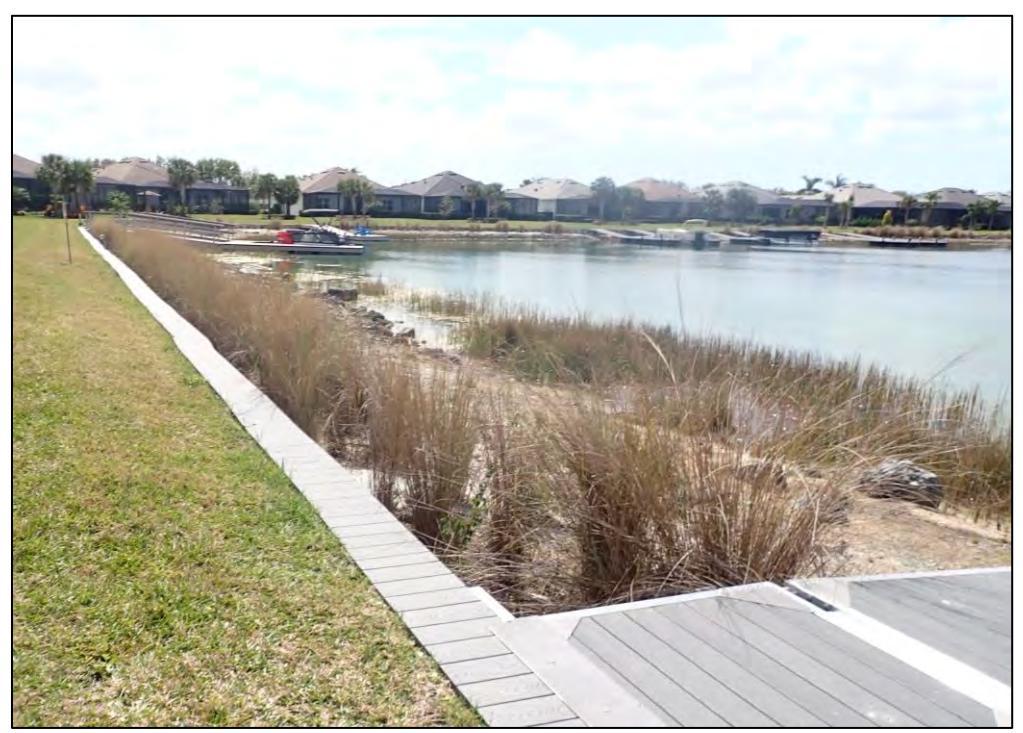
During the site visit, shoreline vegetation, with specific attention to wetland vegetation, was identified at the Project site. American Bulrush (*Schoenoplectus americanus*) and softstem bulrush (*Schoenoplectus tabernaemontani*) (Photo 17) were observed along the shoreline, primarily within the littoral shelf area, and comprised the majority of the observed vegetation. Other intermixed wetland vegetation, although less common, included pickerelweed (*Pontederia cordata*) (Photo 18) and pond cypress (*Taxodium ascendens*). Table 3 provides a summary of all shoreline vegetation species observed on site. An in-water assessment was not conducted; however, it appears that water depths increase drastically immediately waterward of the emergent littoral shelf. It is anticipated that there is no benthic community of significance that will be a concern within the Project footprint.

Photo 17. Soft rush and bulrush along the project shoreline.

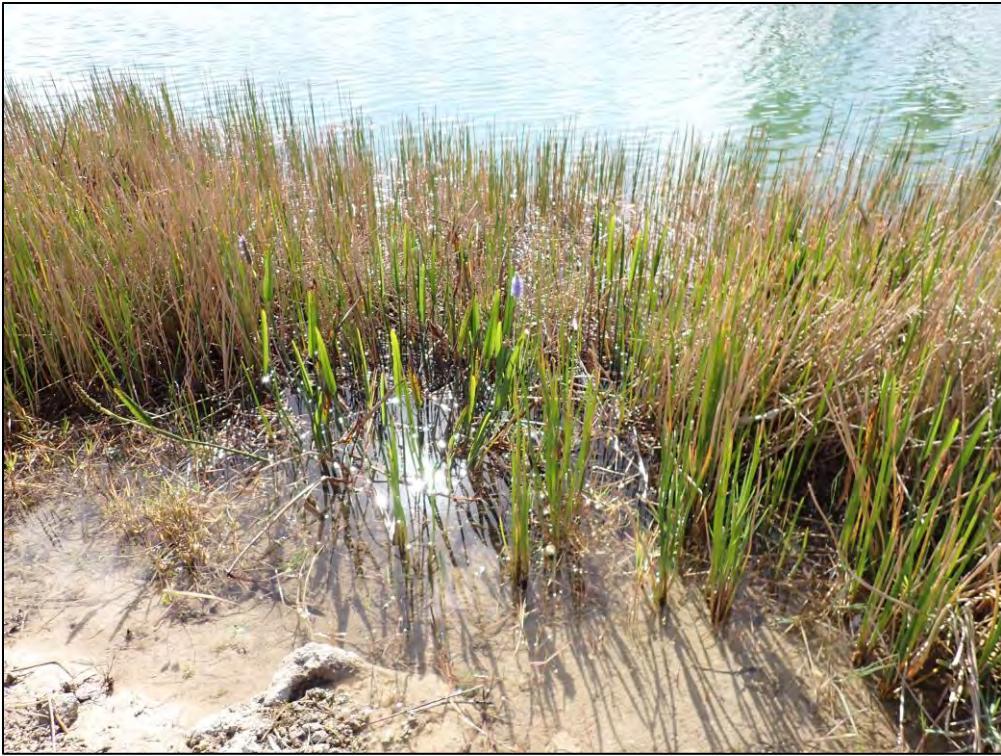
Photo 18. Native pickerel weed and soft rush on the project shoreline.

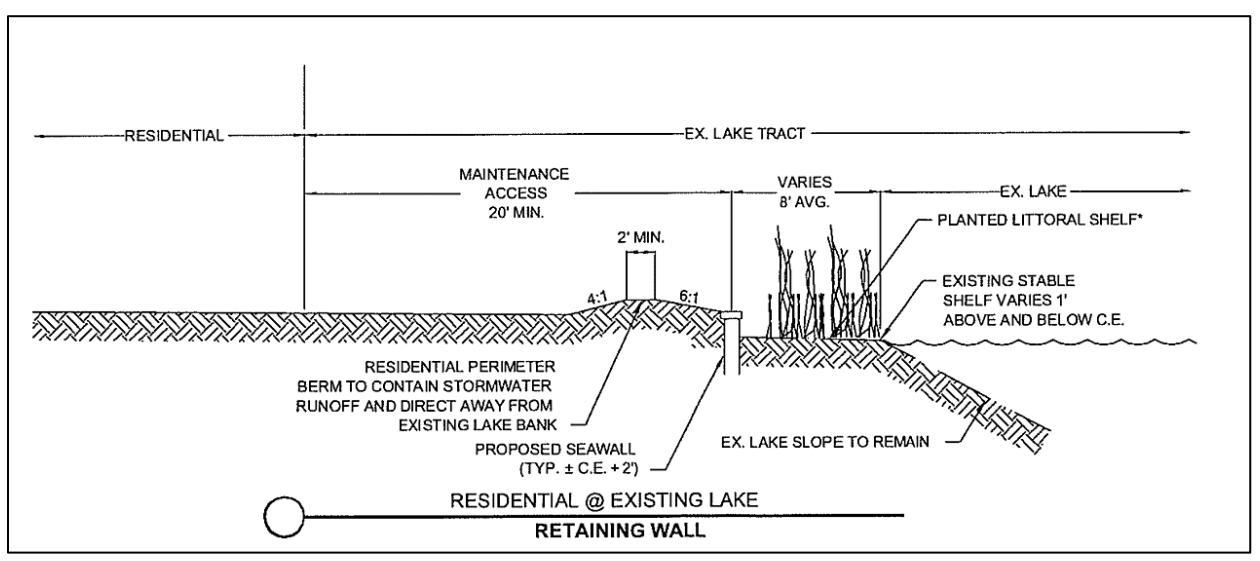
- A minimum lake maintenance easement width of six (6) feet, whereas a lake maintenance easement width of 20 feet is typically required.
- The use of vertical retaining walls as an alternative to the originally proposed riprap breakwater.

Figure 6. County-approved cross-section from administrative amendment ADD2018-10053.

It may be worth noting that the existing littoral plantings do not appear to be faring well, as evident from the March 2024 site visit. It is not clear from preliminary investigations whether this is due to wave action impacting stabilization and survivorship of the plants, or if soil nutrients of the historically mined lake are not adequate for the selected plantings. Innovative planting options that provide protection and/or additional nutrient-rich soil for the proposed vegetation via planters
